Case Study

Drum Booth Upgrade

An aging drum booth had been identified as a potential 'risk area' due to a failing extraction system.

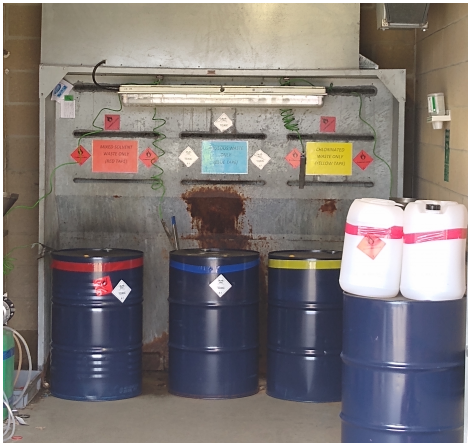
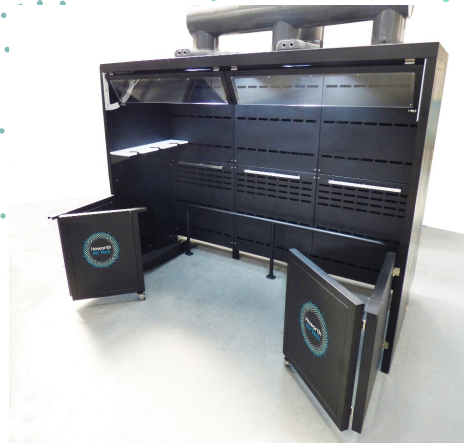
After the initial design phase was concluded, an ergonomic mock-up of the booth was fabricated and delivered to the site for evaluation by the Project Team and Operators, allowing for a thorough assessment of the various process operations. Following the assessment and necessary adjustments, the final design for a Drum Booth capable of handling three waste drums was finalised and granted approval.

- Stainless Steel construction with Armourcote 4220 coating for an enhanced level of protection against hazardous chemicals
- Dedicated extraction fan and controls system
- Bi-fold doors for easier drum access and removal
- ATEX rated
- Drum rail and PTFE 'stops' to protect booth from damage
