Case Study

UCV Maintenance

Do your filters look like this?

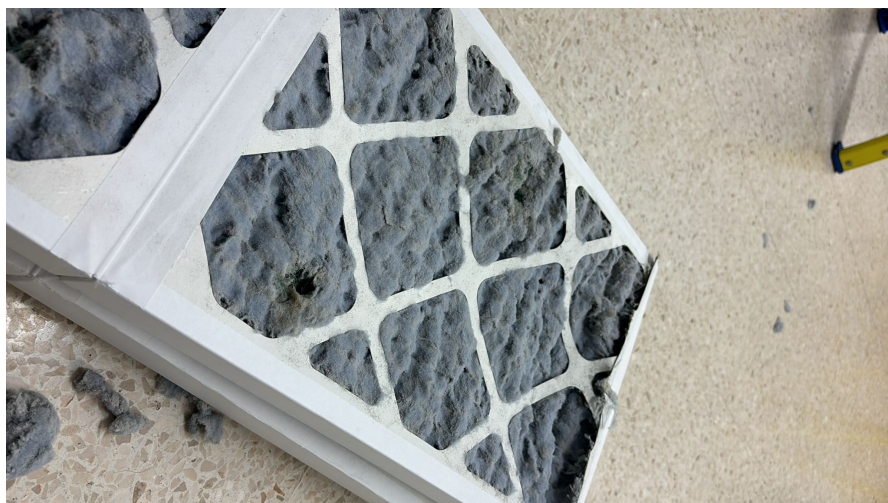
This soiled pre filter was recently discovered on a third party serviced Howorth UCV Canopy. Following their failure to rectify specific issues with the UCV system our team were called in and we swiftly rectified the issues found on site.

Whilst on site we carried out a deeper investigation into the service rota of the UCV system and found inadequate techniques used both Mechanically and Electrically to the UCV System. It is imperative that when critical systems are annually verified and canopies serviced that the AP(V) is present to supervise the sub contracted engineers and that they are competent to execute their duties (in accordance with HTM 00).

It is our recommendation that UCV Systems are maintained annually (at a minimum) inclusive of pre filter replacement, airflow confirmation, filter integrity checks and all other Mechanical and Electrical considerations.
